AIRCRAFT GROUND-FLOTATION INVESTIGATION PART XVI — DATA REPORT ON TEST SECTION 15

U. S. ARMY ENGINEER WATERWAYS EXPERIMENT STATION

TECHNICAL REPORT AFFDL-66-43, PART XVI

SEPTEMBER 1966

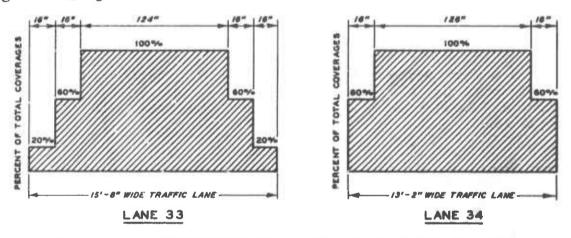
Traffic was applied to the test lanes in a nonuniform pattern with intensity of traffic being varied within each lane. Traffic so distributed within a traffic lane simulates as nearly as feasible the bell-shaped traffic distribution curve which results from the wander of aircraft from the lane center line. The coverage levels referred to in the tables and text herein are the total number of coverages applied to the loo percent coverage zone. The corresponding number of coverages applied to the outer traffic zones is proportional to the percentage factor for the respective zones as shown in figure 1. Each pass of the multiwheel assembly was equivalent to 1.25 coverages on lane 33 and to 1.33 coverages on lane 34.

Figure 1. Traffic distribution patterns on Test Section 15

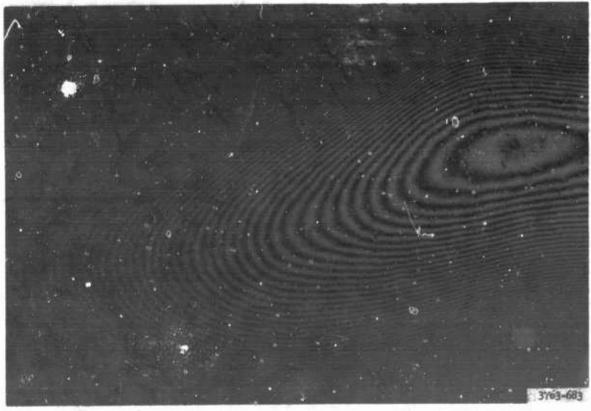
Figure 5. Item 2, lane 33, prior to traffic

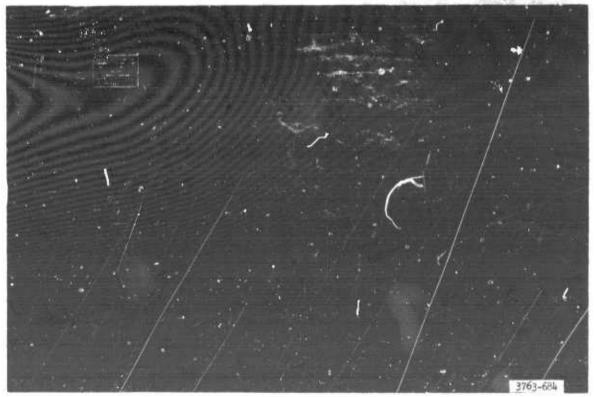
Figure 7. Item 3, lane 33, prior to traffic

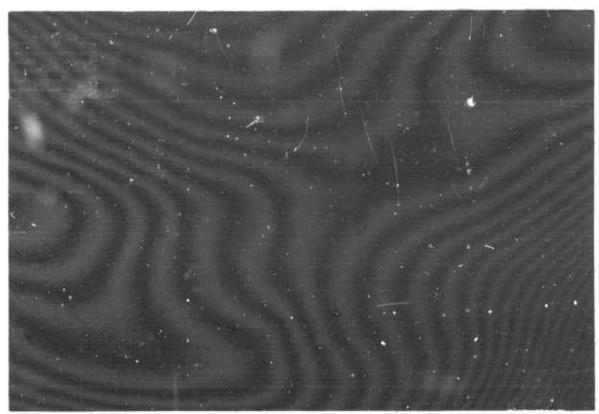
Item 2. Item 2 prior to traffic was similar in appearance to item 2, lane 33 (figure 5). At 49 coverages, the item was considered failed due to roughness (figure 10). The rated CBR for the item was 4.7.

- Roughness. Average transverse and diagonal differential deformations were 5.35 and 5.00 in., respectively, at 49 coverages.
 Ruts were less severe with an average depth of 3.28 in. (table 1).
- b. Deformation. Figure 15 shows cross-section deformations for three stations along the item at 49 coverages. Profile deformations at the same coverage level are shown in figure 16. The subgrade settled relatively uniformly along the item.
- c. Deflection. Total and elastic subgrade deflections were 0.9 and

Figure 10. Item 2, lane 34. Transverse straightedge shows roughness at 49 coverages (failure)

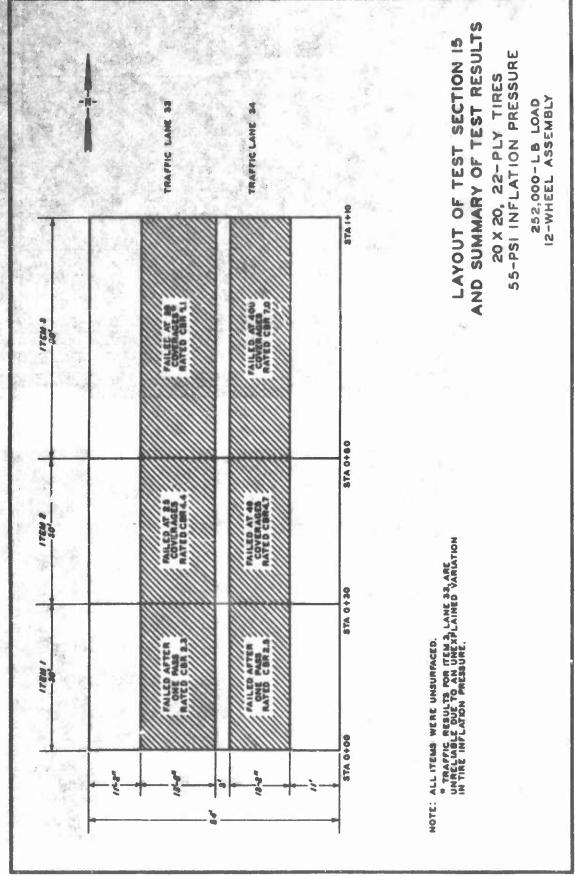
Figure 12

Tests on Section 15 are one phase of a comprehensive research program to develop ground-flotation criteria for heavy cargo-type aircraft. Section 15 consisted of two similar unsurfaced traffic lanes, lanes 33 and 34, each of which was divided into three items (figure 12) having different subgrade CBR values.

Two unsurfaced traffic lanes, each divided into three items, were constructed in the test section. Different subgrade strengths were obtained in the items (figure 12) by controlling the water contents and compaction effort.

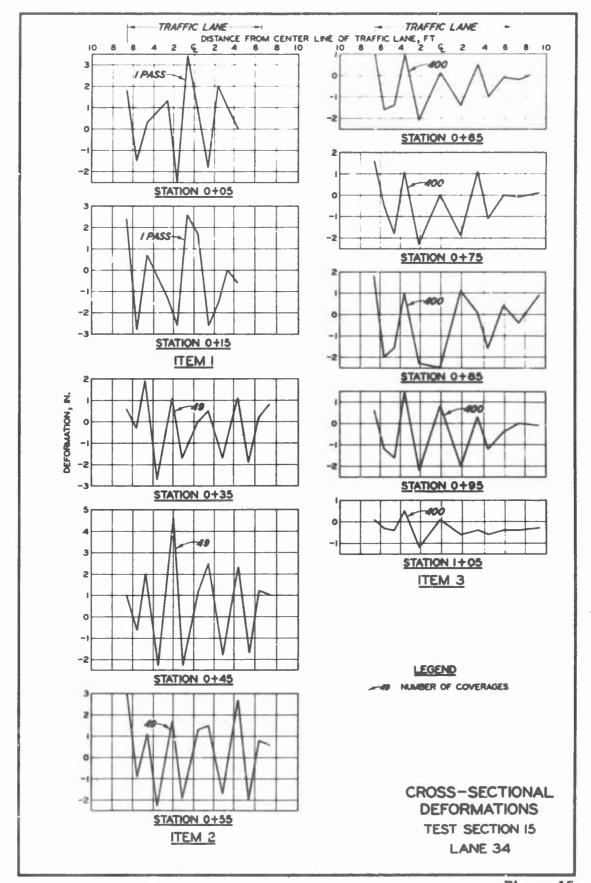
Figure 15

- a. Roughness. No differential deformations were recorded on the item. The average rut depth after 1 pass was 9.7 in. (table 1).
- b. Deformation. The severe ruts produced by 1 pass of the load vehicle are evident in the cross-section plots in figure 15.

- b. Deformation. Cross-section deformations in figure 15 show the extent of surface deterioration at failure. General settlement along the item length is indicated in the profile deformation plot in figure 16 for 400 coverages.

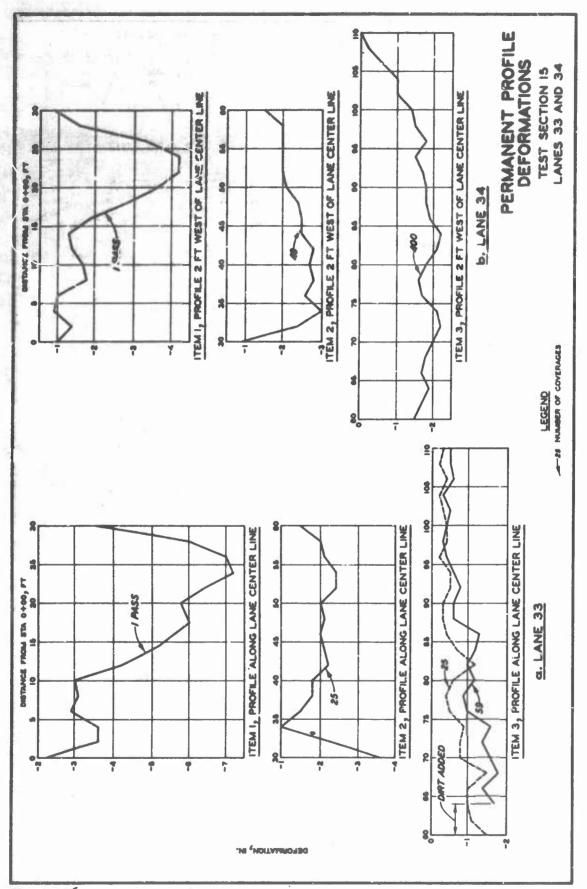
Figure 16 shows a profile along a rut path near the lane center line. The profile deformation increased steadily in the first 25 ft of the item and decreased thereafter.
- c. Deflection. The deflection measurement pin was badly bent due to severe rutting and no usable measurements were obtained on item 1.
- d. Rolling resistance. Peak and rolling drawbar pulls for 1 pass of the load vehicle were 38.0 and 28.3 kips, respectively.
